CASE STUDY OF FIRE IN RESIDENTIAL BUILDING

Executive Summary:

This case study revolves around a recent fire in a residential building, its probable cause and the role of agencies to prevent them.

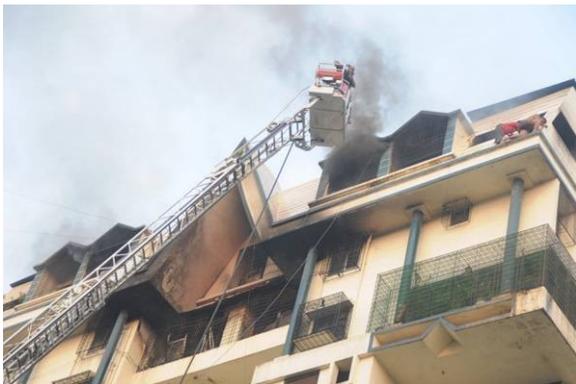
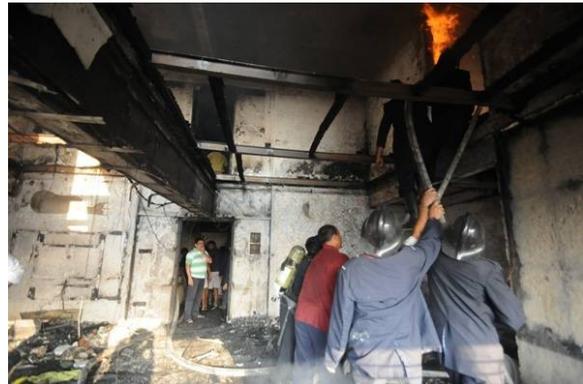
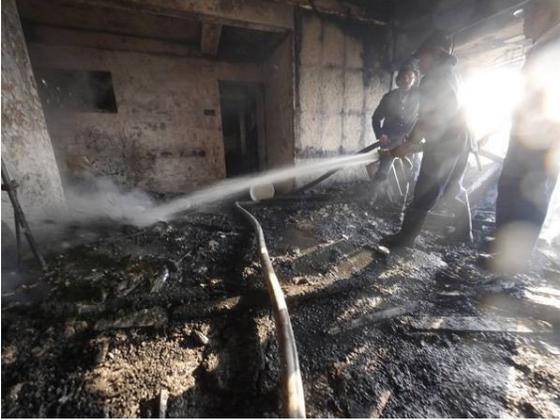
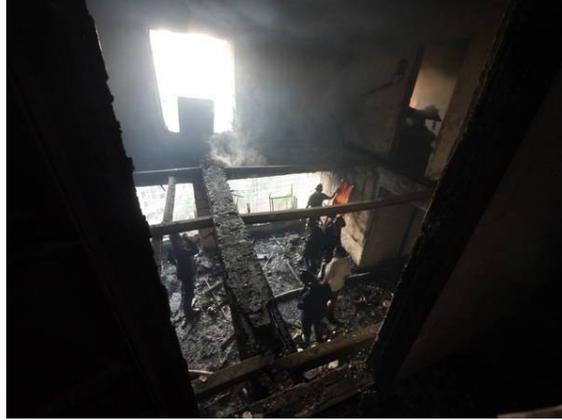
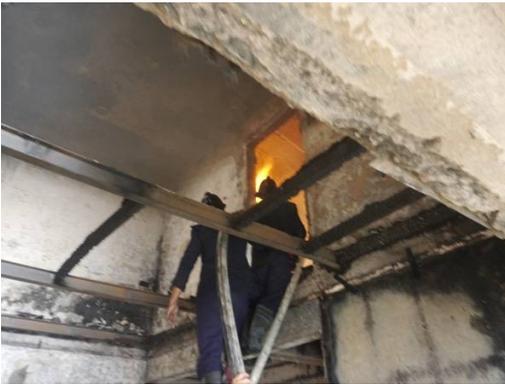
A fire broke out in a penthouse of a building in Thane area. The cause of the fire is unknown, but certain tell tale marks lead to probable cause of loose contact in the plug circuit, which has gone unnoticed for a long period.

This fire has left behind two dead persons who were trapped in the apartment, and destroyed completely the two floor apartment. Certain pictures from the web are attached to show the extent of damage.

Disaster management personnel said the monstrous blaze could not be controlled as the entire furniture, flooring and the staircase connecting the duplex apartment was wooden. The house fire spread quickly and in the blink of an eye the entire apartment was up in flames. There was no way to douse these flames at that point of time as the entire apartment was decorated up with wooden furniture. The house flooring was wood-based, the staircase that led to the duplex apartment was made of wood and so were all the wardrobes and other furniture.

*** Cause of electric fire is not known, but news item attributes to short in plug circuit.***

- All should periodically inspect the plug socket of equipments when loaded. A touch will reveal whether the plug is warm or normal. If found to be warm or hot, there will be tell tale marks of loose contact by blackening of pins. In this case both the plug and the socket needs replacement.
- Extension boards should not be used for high current equipments like Water heater, Refrigerator, Cooking heater, Air conditioner etc.
- This penthouse was full of fashionable interiors with lavish use of wood, varnish etc. So the fire was of massive scale. Avoid massive use of wood, veneer, polish, oil paint, these are only ornamental.
- All interior wiring needs change every 15-20 years depending on the additional equipment load one adds to his comforts.
