CASE STUDY OF RECTIFICATION OF DOUBLE CAGE ROTOR OF BOILER FEED PUMP MOTOR

If repairers do not take their job seriously and execute the repair work with lack of knowledge, it leads to catastrophe. The author in this paper brings out the case of malfunction of a repaired double cage rotor of Boiler feed pump motor having rating 1850HP, 3000V.

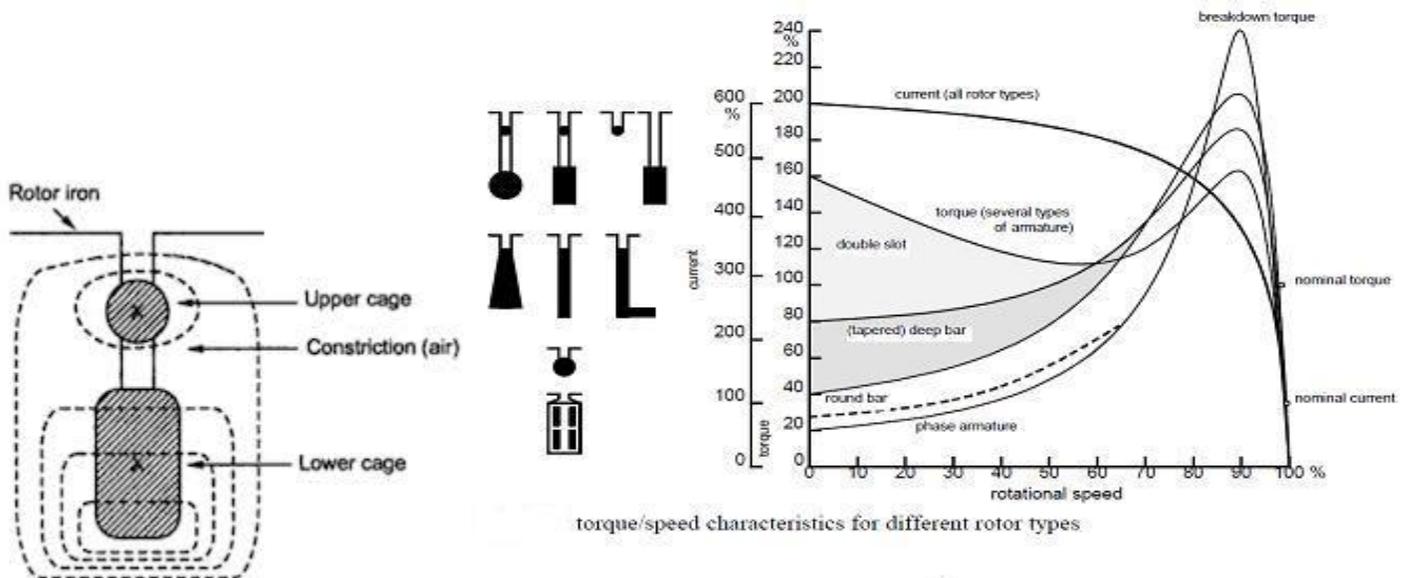
Double cage rotor is used when the motor has to start at full load. At the time of starting the motor requires high resistance & low reactance in the rotor circuit. The thick rotor bars present in the outer periphery & connected to the outer ring helps to achieve this. When the motor picks up speed, the need is for low resistance & high reactance in the rotor circuit. The inner cage having copper flats embedded deep in the lamination & connected to the inner ring provides this requirement and the motor runs at its rated speed. The sketch provided below gives an example of the positioning the rotor bars.
